## CENTRAL VENOUS CATHETER MALPOSITION AS AN IMMEDIATE COMPLICATION AFTER INSERTION

**Autores:** Ariel Sosa Remón MD<sup>1</sup>, Ana Esperanza Jerez Álvarez MD<sup>2</sup>, Gelacio Alexey Jeréz Alvarez<sup>3</sup>

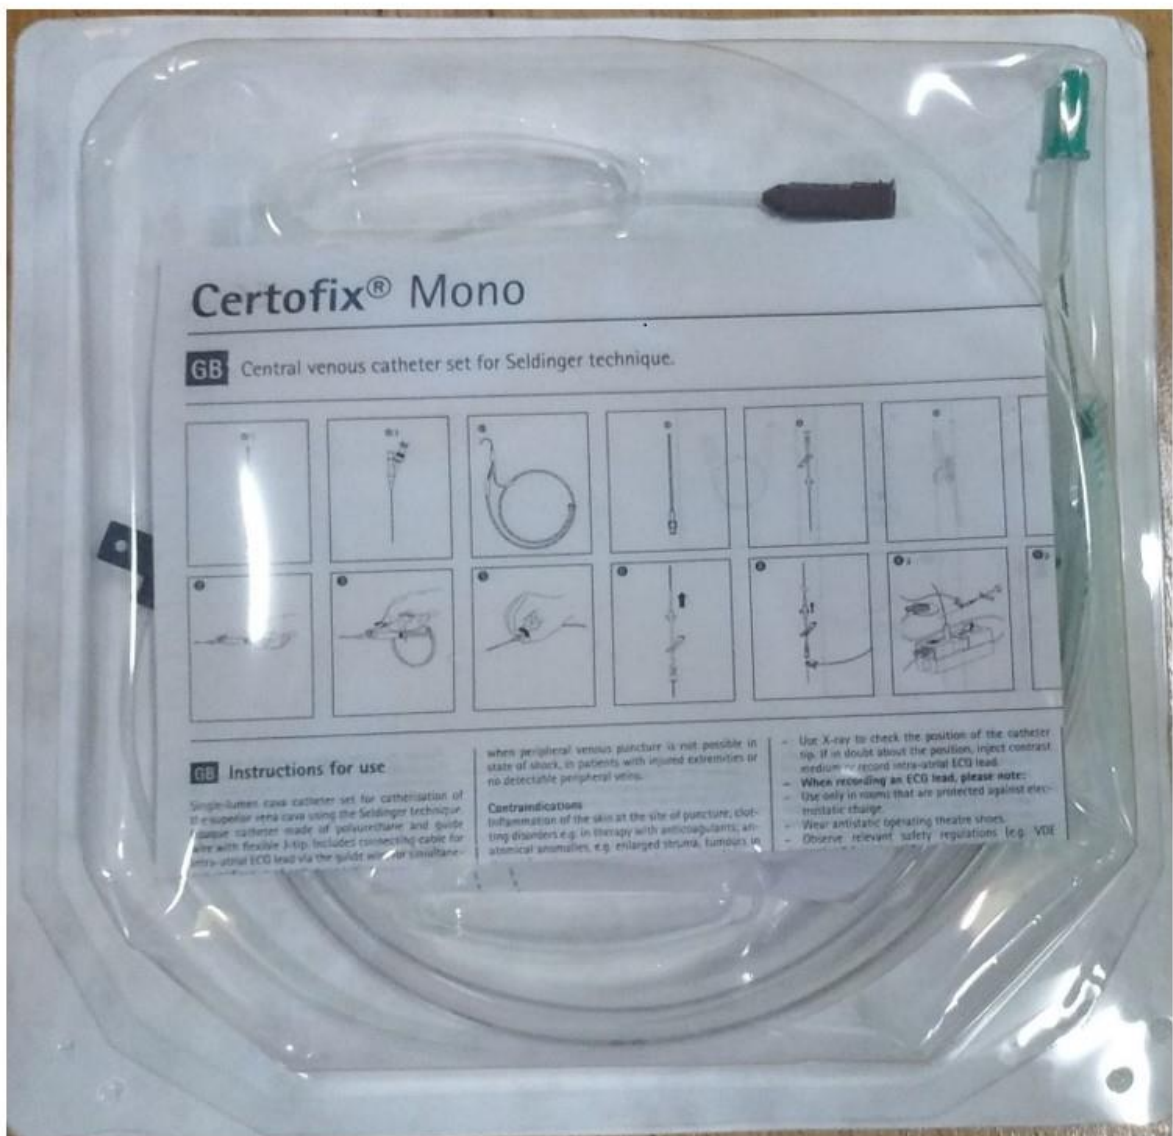
**Figure 1. Certofix® Mono S 430 Catheter.**

On admission, arterial hypotension (90/60 mmHg) and clinical symptoms corresponding to an intracranial hypertension syndrome were observed. This reason demanded the implantation of a CVC for continuous infusion of vasoactive drugs. A Certofix<sup>®</sup> Mono S 430 CVC was used for the procedure (Annex Figure 1).

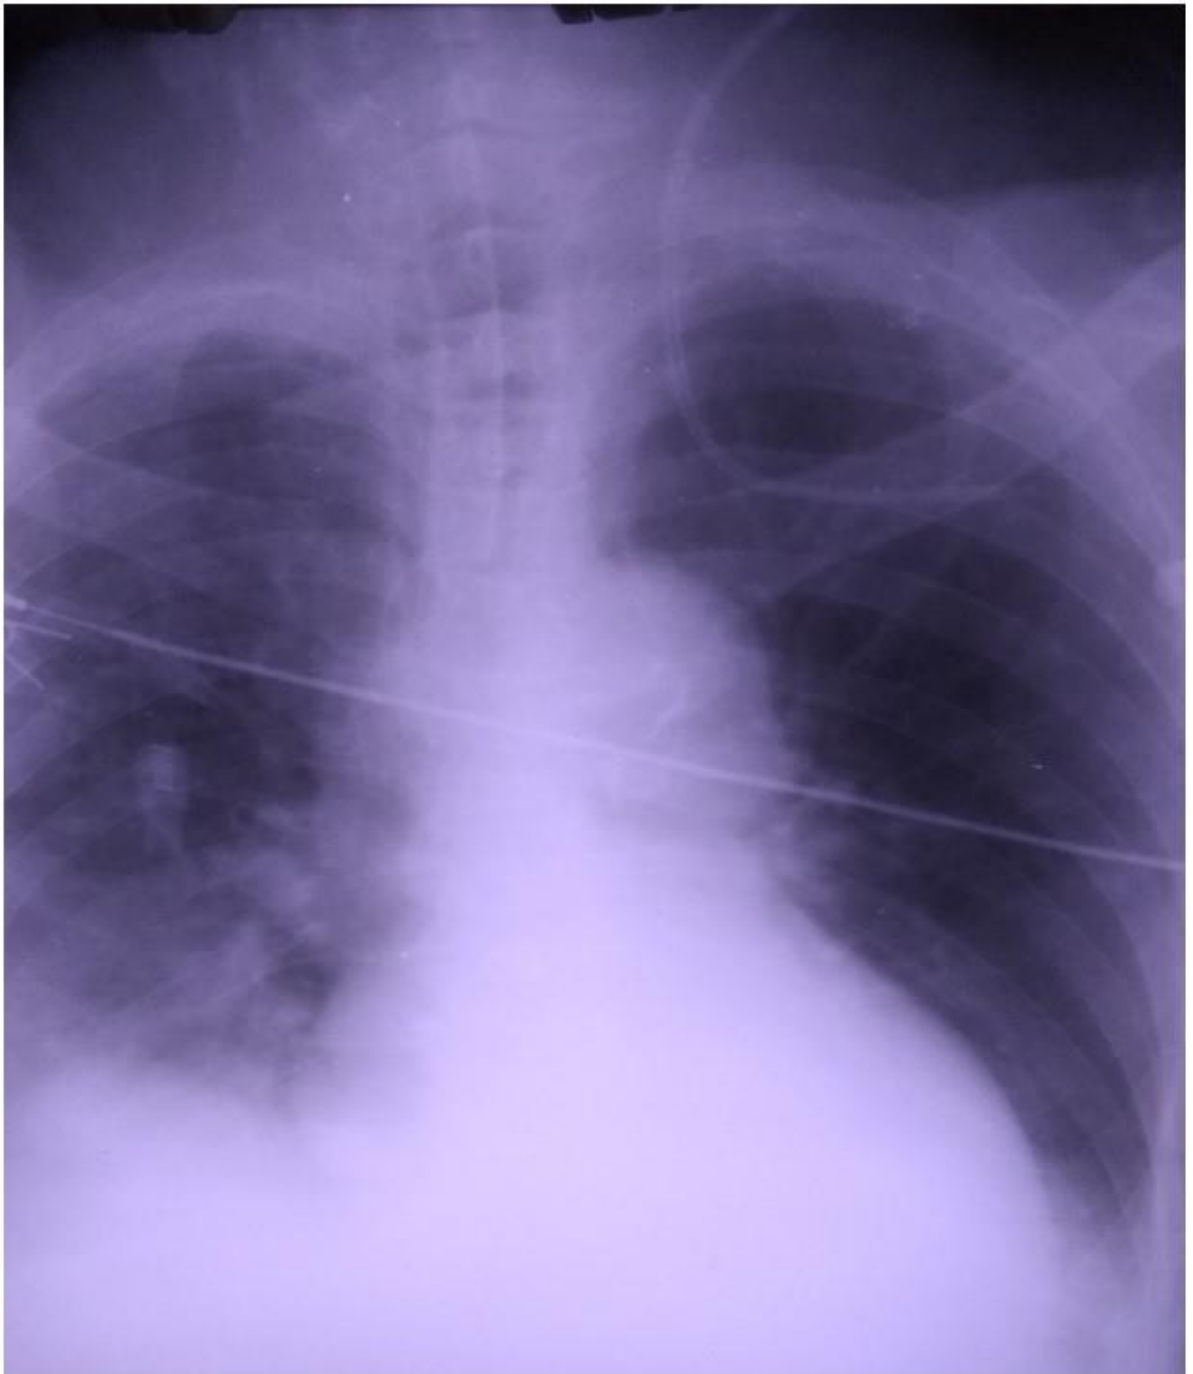
The procedure was performed using the Seldinger method and the anatomical route of the left posterior jugular vein was used. The technique was performed without difficulty, the vein was cannulated on the first attempt and there were no immediate complications during the procedure. However, upon radiographic verification, the malposition of the CVC was evidenced, which took a route towards the left subclavian vein (Annex Figure 2).

**Figure 2. Radiographic evidence of CVC malposition towards the ipsilateral subclavian vein. Anteroposterior view chest radiograph. Source: authors.**

Immediately it was decided to remove the CVC and perform the procedure again, this time a more experienced specialist was called to perform it and the

Subclavian catheters can be placed in the ipsilateral internal jugular vein or in the contralateral subclavian vein. The jugular catheters can follow the course of the subclavian and also the jugular on the opposite side,<sup>6</sup> as was the case presented in this occasion. Other alternatives that can collaborate with a bad position of the catheter tip are an anatomical variant or stenosis of the great veins.<sup>9</sup> Poor positioning of the CVC is associated with other complications, such as venous thrombosis, loss of central venous pressure measurement by remaining in narrower veins and with less flow or altering the flow and more possibilities of local damage, damage to vascular structures and greater mechanical and chemical damage to the vein due to the drugs to be infused and, therefore, greater risk of perforation.<sup>6,7</sup>

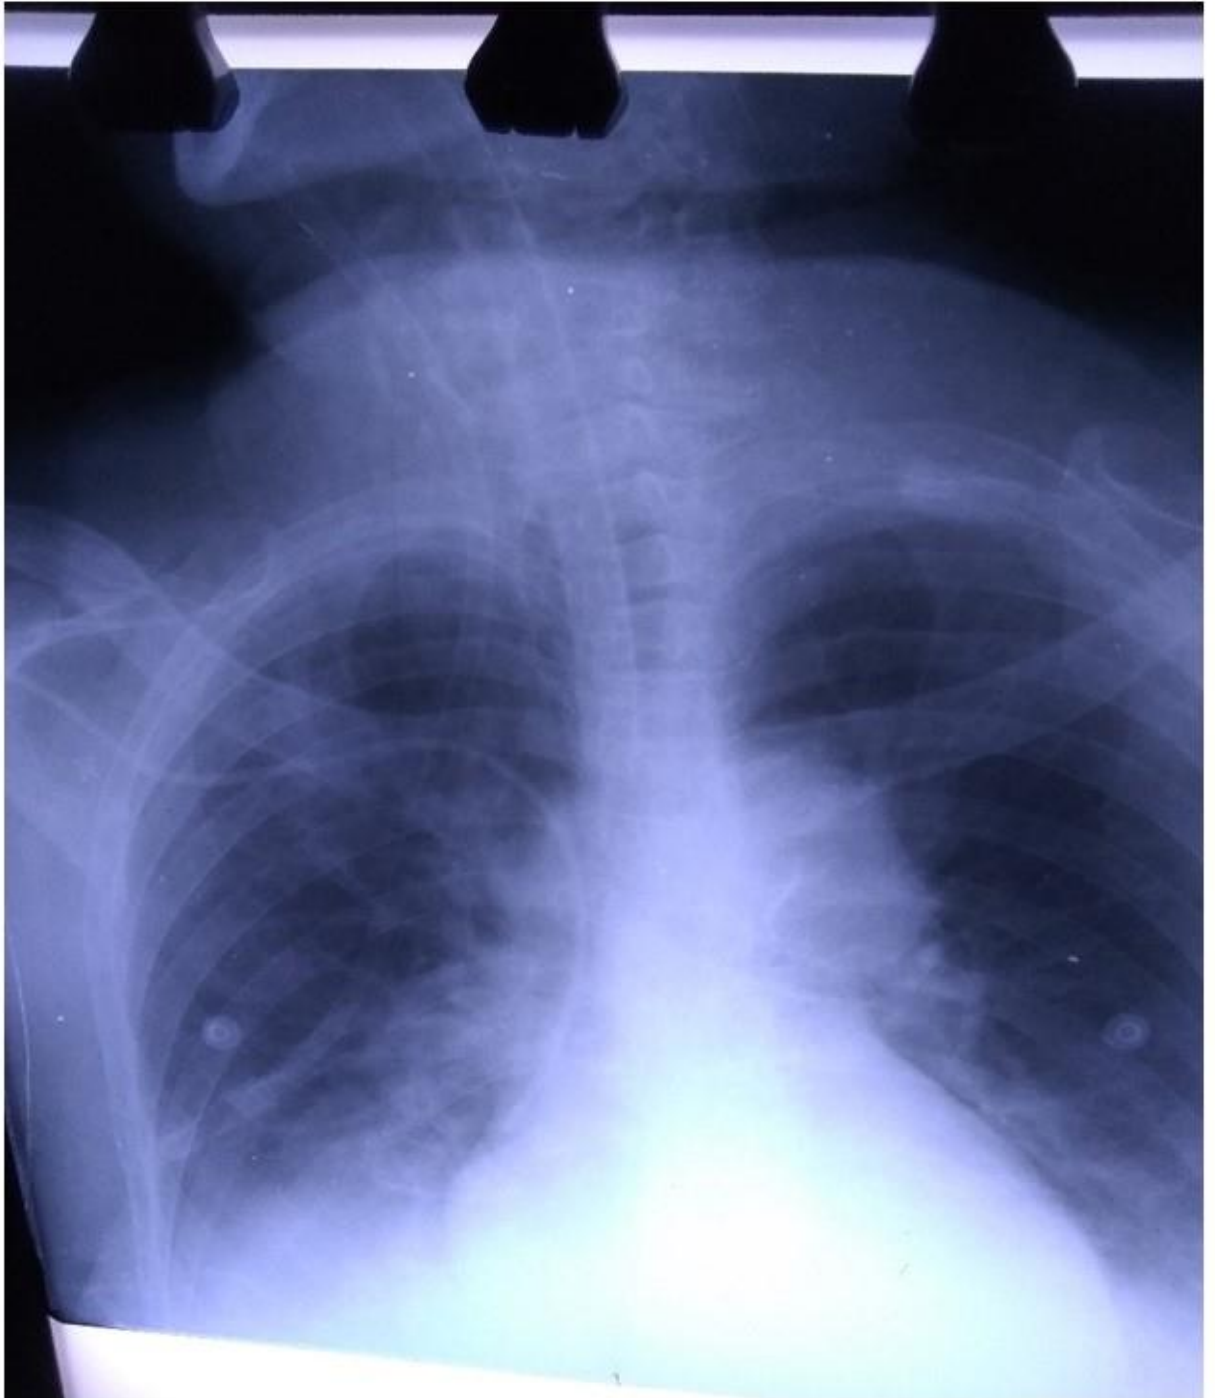
Subsequent radiographic verification showed the correct placement of the CVC in projection to the right atrium and to the edge of the atrial wall (Annex Figure 3).

**Figure 3. Radiographic evidence of the correct position of the CVC. Chest X-ray in anterior-posterior view. Source: authors**

procedure was performed through the right subclavian route and by Seldinger's method. Once again there were no complications during the procedure.
